# **GROUNDWATER REMEDICATION**

## **Kanpur, India**

*A Case study*

**13<sup>th</sup> Poverty and Environment Partnership Meeting**

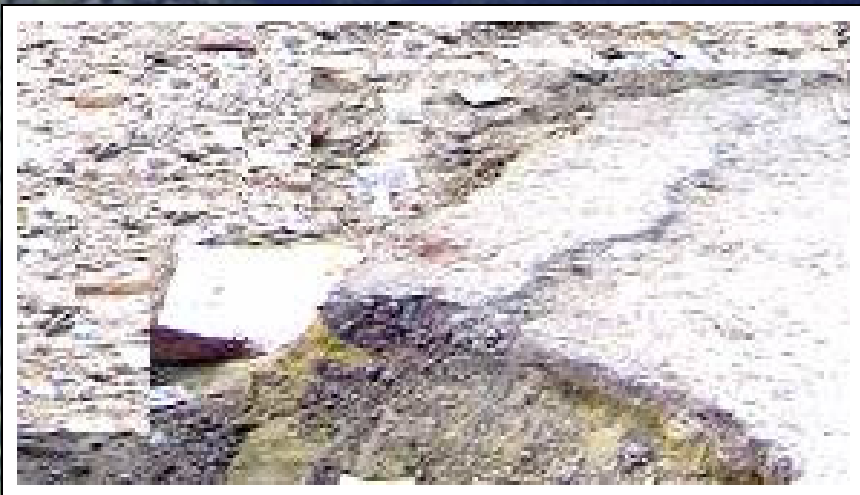
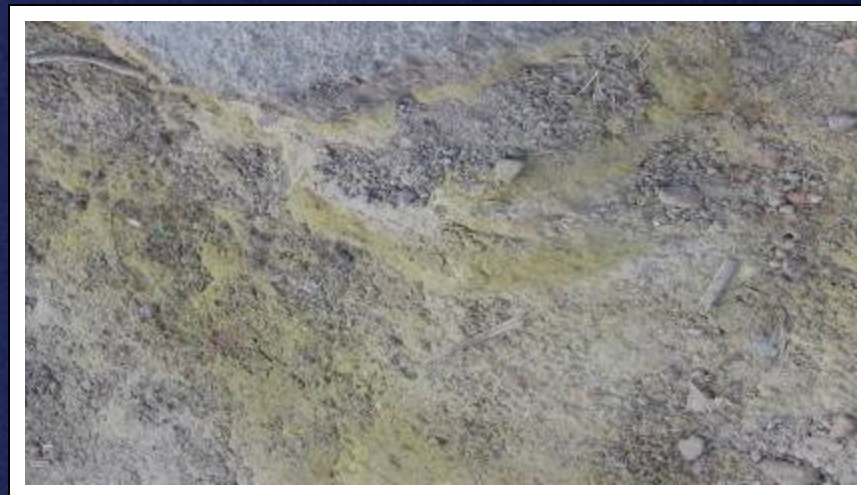
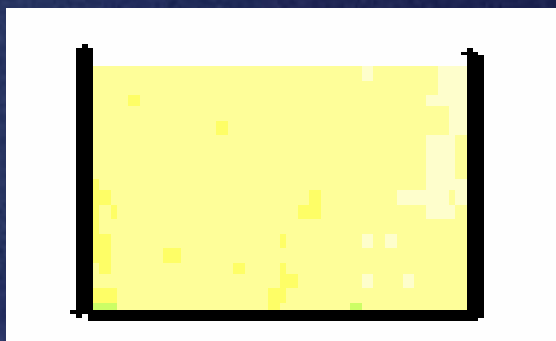
*The (Cr) anomaly resulted from  
sludge (5-10%  $\text{Cr}_2\text{O}_3$  by wt)*

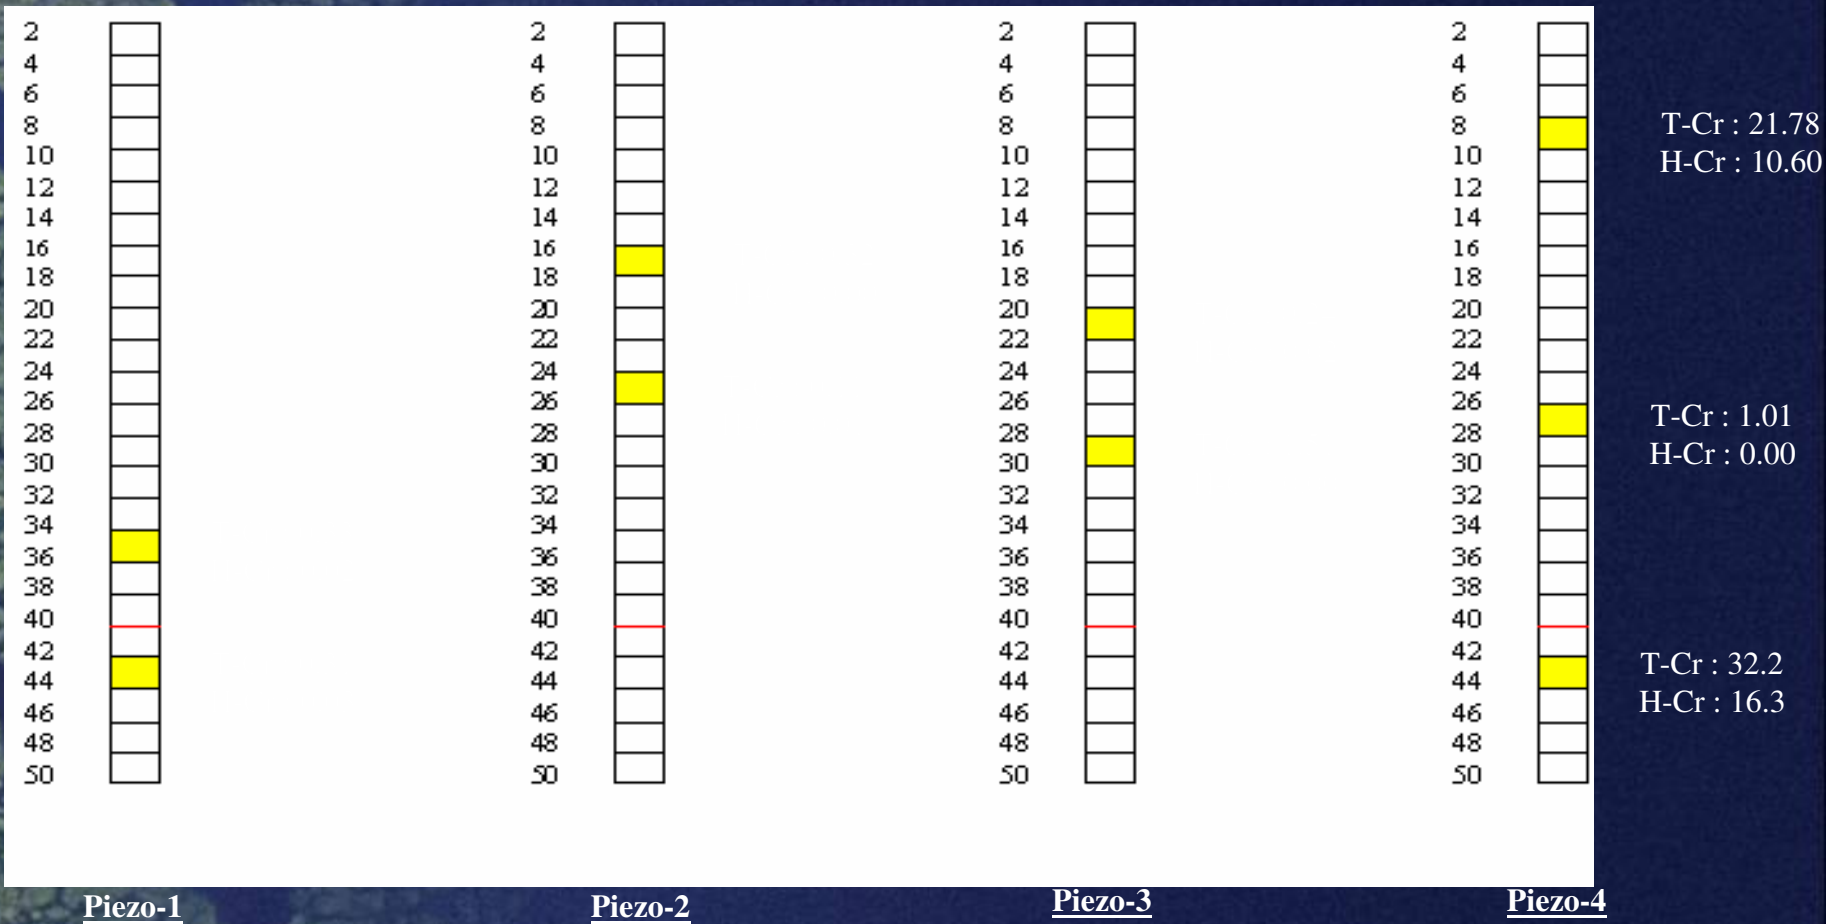
# Stratification of Cr VI

*Concentration in mg/l*  
 \* meter below ground level
